## **APPENDIX 5. Worksites in Focus**

## Drive-Thru Classroom Self-Guided Tour

## Potter County Horseshoe Road

## Fulton County Dutch Corner Road

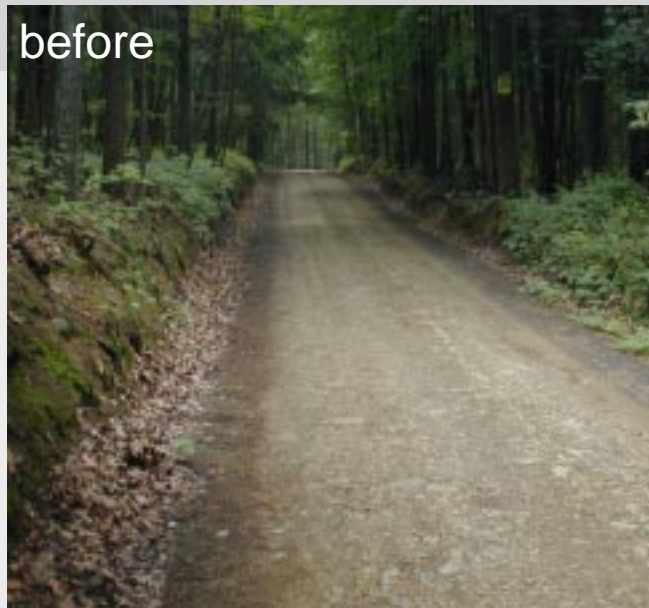
before

Years of wear and tear, machine maintenance and erosion caused the road surface to become entrenched below its banks. This captures all water from surface and near-surface drainage. The captured water gains energy as it flows down the road causing it to erode the road surface and side ditches. Road banks collapse into ditches mandating more machine work, which further lowers the road. Observe how the natural surface drainage has been restored by filling the road back to its original elevation and stopping the endless cycle of erosion and repair.

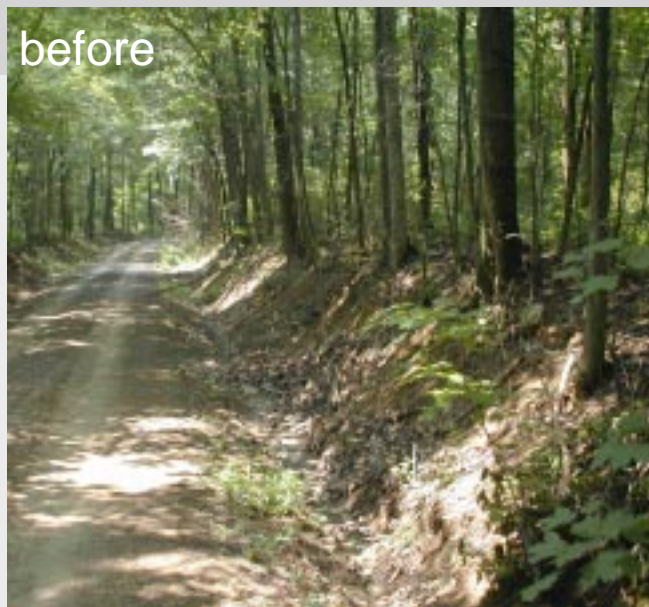
before

In addition to the sunken road surface, notice the density of vegetation shown in this photo. The shade is so dense, plants whose roots could have held the bank's soil in place did not have enough light to grow. Also, look at how the treetops lean over the road shading it. Individual trees, which were not structurally sound or vigorous were removed. If not disrupted by deer browsing, vigorous strong young plants will now grow with more full light and provide protection for the soil. Trees growing close to the road will receive light from both sides and develop even crowns.

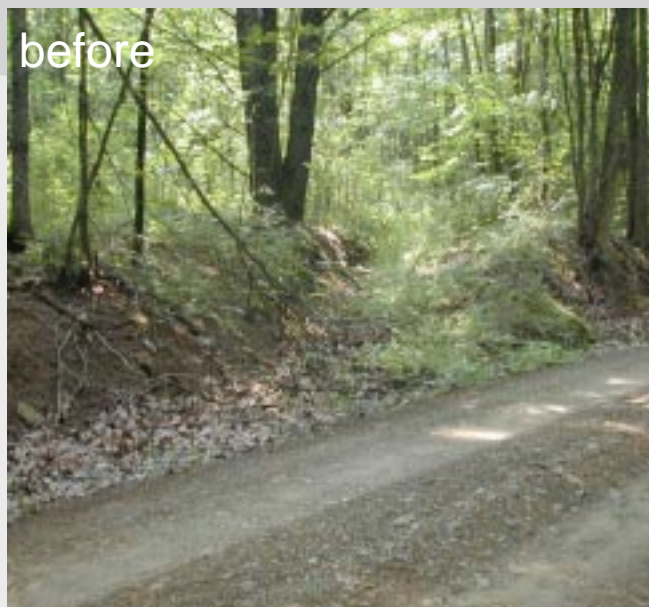
before

Road drainage constructed without concern for increasing environmental harm and maintenance costs frequently cuts banks vertically and makes steep drainage patterns. The maintenance practice at this location was to dig excess material out of the turnout and pile it beside the drainage course, constricting the width of flow causing the water to move faster and be more erosive. Now, observe how drainage from the restored road height does not require a ditch, and how flow is dispersed over a wide area at a shallow angle.

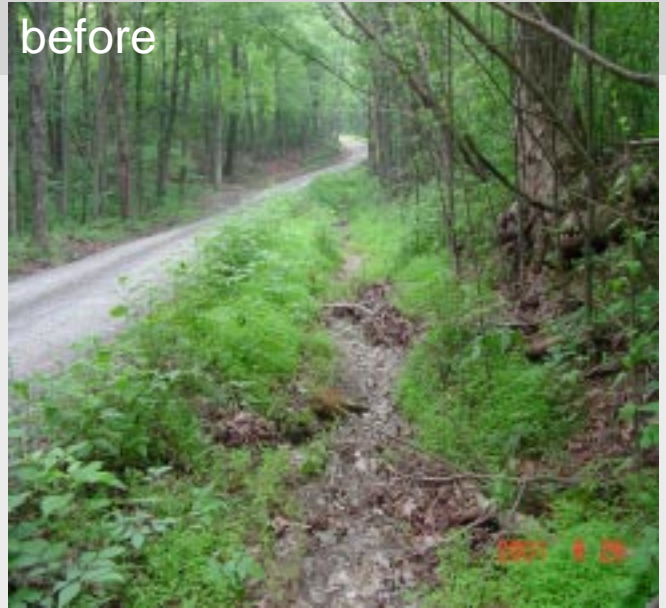
The picture shows evidence of fast moving water. Tangled brush mattresses and large rocks washed clean indicate a strong erosive force generated by concentrated swift flow. Contrast how wide and deep the pictured ditch is compared to the present ditch.

Large rocks were placed in the ditch before the road was filled in. Known as a “French Drain”, it serves to conduct clear sub-surface water downgrade without forcing it to come to the surface, where soil particles can be carried as unwanted sediment to the stream. To some extent, sub-drains help keep the road base drained, and therefore stronger.

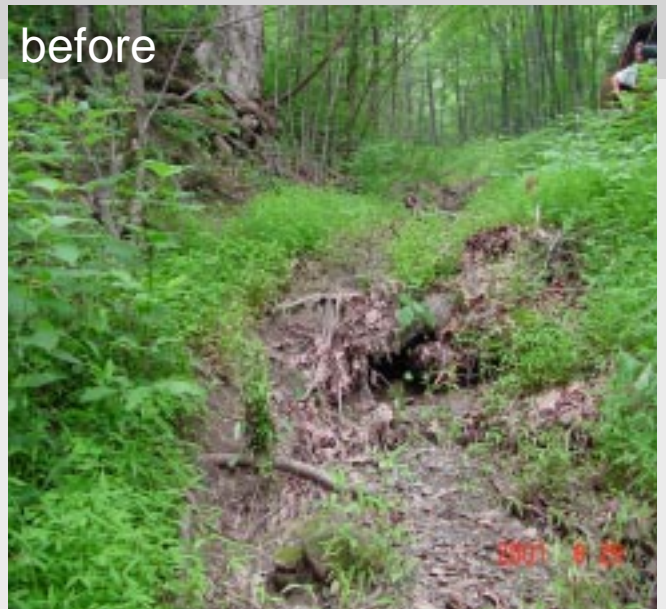
before

Concentrated flow washed out the road bank at this location sending a plume of sediment to the stream. Over time, that concentrated flow further eroded 400 ft. of ditchline discharging even more sediment directly into the stream.

A non-corroding cross-pipe was added under the road to harmlessly direct this flow to the forest floor on the other side of the road. The pipe entrance was raised to lessen the energy the water gained by falling into the pipe. On the other side, the pipe discharges at natural ground elevation. Dispersed there in a natural pattern, the water can infiltrate into the ground as if the road had never been built.

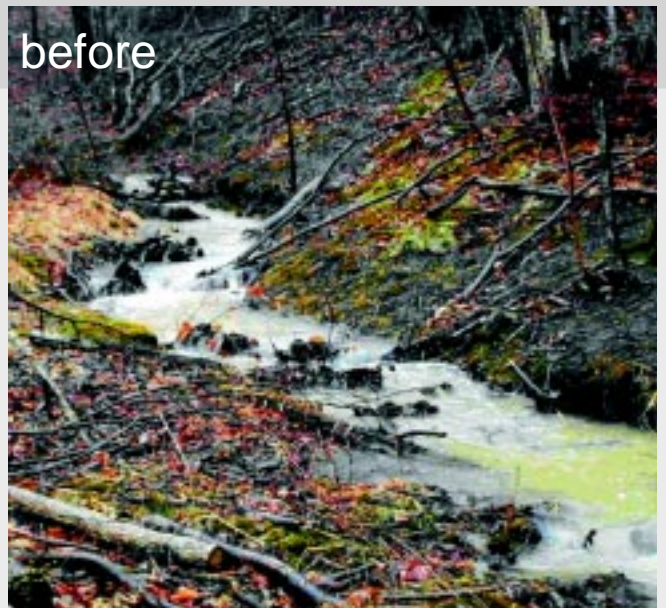
before

A stream will naturally form a channel with the width and depth to contain average flows while allowing naturally-occurring high flows to spill over its bank and onto its floodplain. By spreading high flows out over the floodplain, the excess energy and force of the water is released. Compare the size and shape of the stream channel here to that below the road crossing. The concentrated volumes and velocities of the road drainage have cut a deep gully-shaped channel disconnecting the stream from its floodplain thereby preventing energy dissipation. When all the energy of high flow events is confined within the channel, the cycle of repeated “down cutting” results.

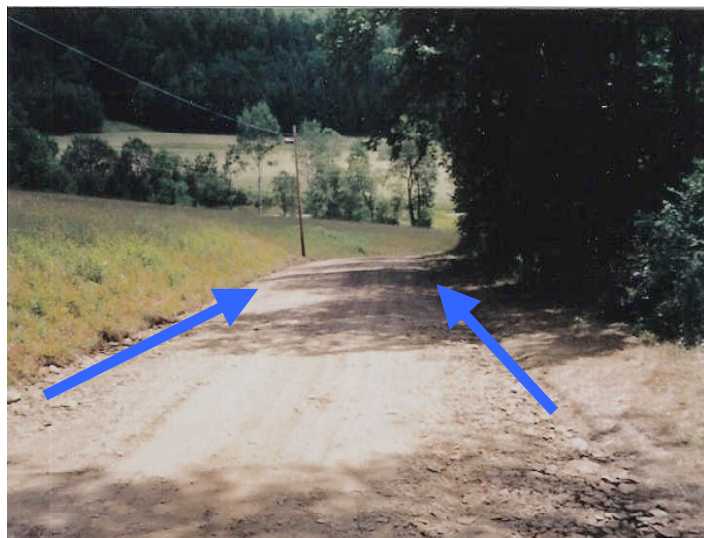
Routine maintenance operations and the wear and tear of traffic had the cumulative effect of lowering the road elevation in relation to the surrounding terrain (see photo). The resulting entrenched road trapped road drainage. Confined by the road, this water concentrated in parallel ditches and gained velocity. As the volume and velocity increased, more and more valuable road material was washed away, polluting nearby Pine Creek.

Before: The entrenched road trapped road drainage resulting in fast-moving concentrated ditchflow. This water eroded road material and deposited it directly into Pine Creek.

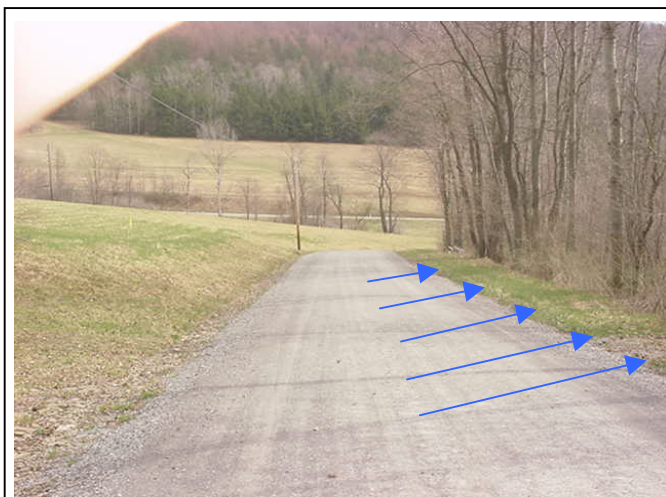
After: The road profile was raised eliminating ditchflow on the downslope side of the road. Drainage that was trapped on the entrenched road can now sheet flow freely off the road into surrounding vegetation. Because the water does not have the opportunity to gain velocity, its erosive potential is greatly reduced.

**Filling the road:** The elevation of the road was raised by filling the road profile. The added elevation eliminated the need for parallel ditches and allowed drainage to sheet flow into the surrounding terrain through vegetated buffers, removing sediment-laden surface flow to Pine Creek.

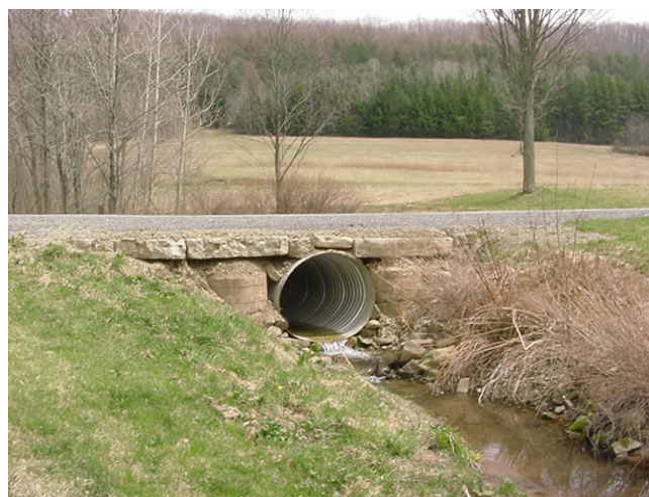
After: The pipe was re-sized and the road raised for proper cover over the new installation.

**Adequate Culvert Size:** A hydrologic & hydraulic analysis was used to determine the proper size of the culvert needed for the stream crossing. The existing 30" round concrete pipe was replaced by a 77"x 52" squash pipe. The road was raised to ensure proper cover over the new pipe.

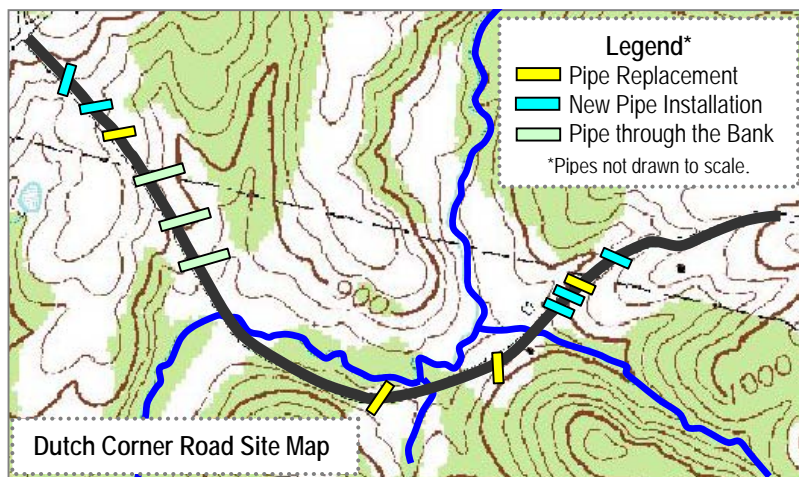
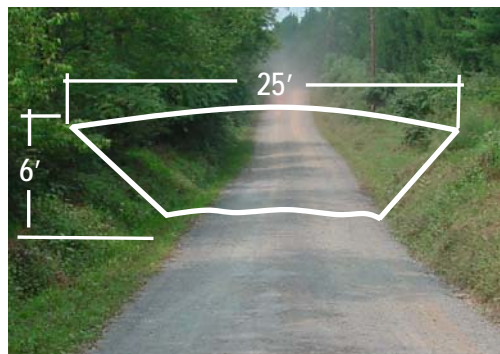
Raising the road elevation to the elevation of the surrounding landscape was impractical because of the amount of material required (above).

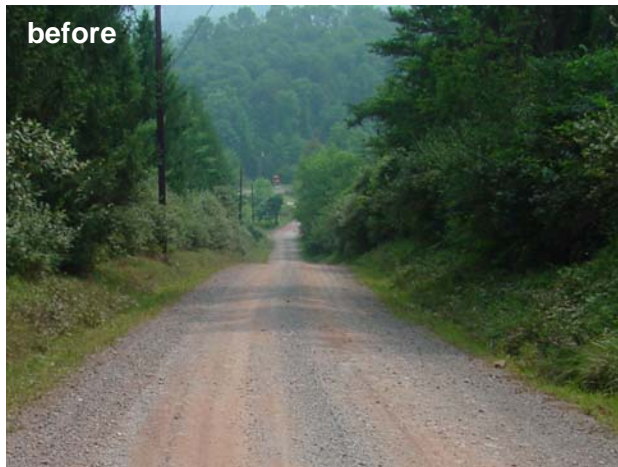
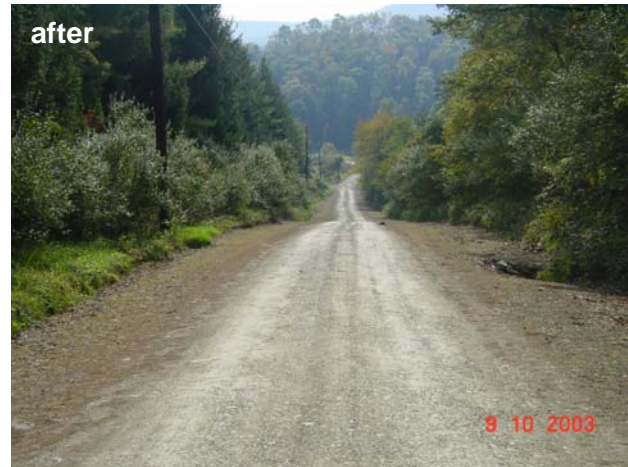
**Before and After Shale Placement.** Before, severely entrenched road slopes steeply to stream at the bottom of the hill. After, cross-pipes are added to divide drainage and reduce concentrated flow and the road elevation is raised 2' to cover the new pipes.

**Road profile.** Shale was placed on steep entrenched areas to a maximum depth of 2 feet to obtain adequate cover on new crosspipes. Road surface was topped with Driving Surface Aggregate (DSA) for improved performance.

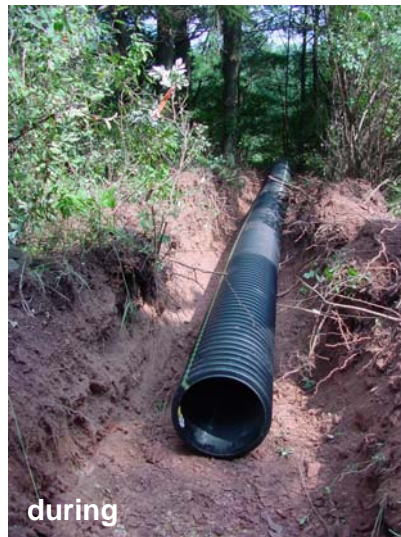
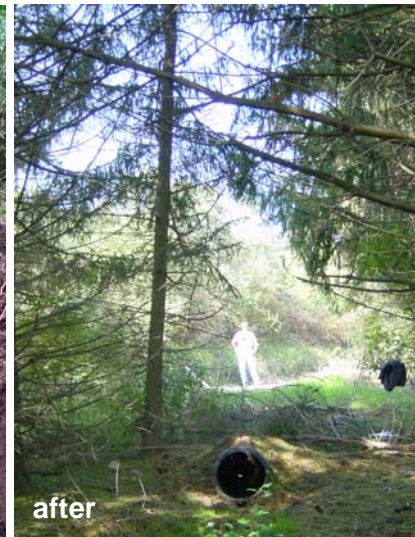
**Pipes Through the Bank.** Note the depth of the trench during construction. After construction the pipe has been covered and stabilized with vegetation.

**Adding crosspipes and installing pipes through the bank.** 3 existing crosspipes were replaced and 9 new drainage pipes were added. 3 of the 9 were installed through the bank. Increased road drainage capacity minimizes concentrated flow before sufficient volume and velocity can build to strong erosive force.
